# SPECIAL AIRWORTHINESS INFORMATION BULLETIN

CE-05-12  
November 4, 2004

This Special Airworthiness Information Bulletin alerts you, owners and operators of **EVEKTOR AEROTECHNIK L-13SW and L-13SE motor gliders**, that the Czech Republic Civil Aviation Authority (CAA) has issued Airworthiness Directive (AD) CAA-AD-026/2002, dated March 29, 2002. This AD calls for the installation of a metal strainer to cover the engine inlet and protect the carburetor from ingesting impurities. The following serial numbers are affected:

**MANDATORY BULLETIN****No. SW 13-053a**

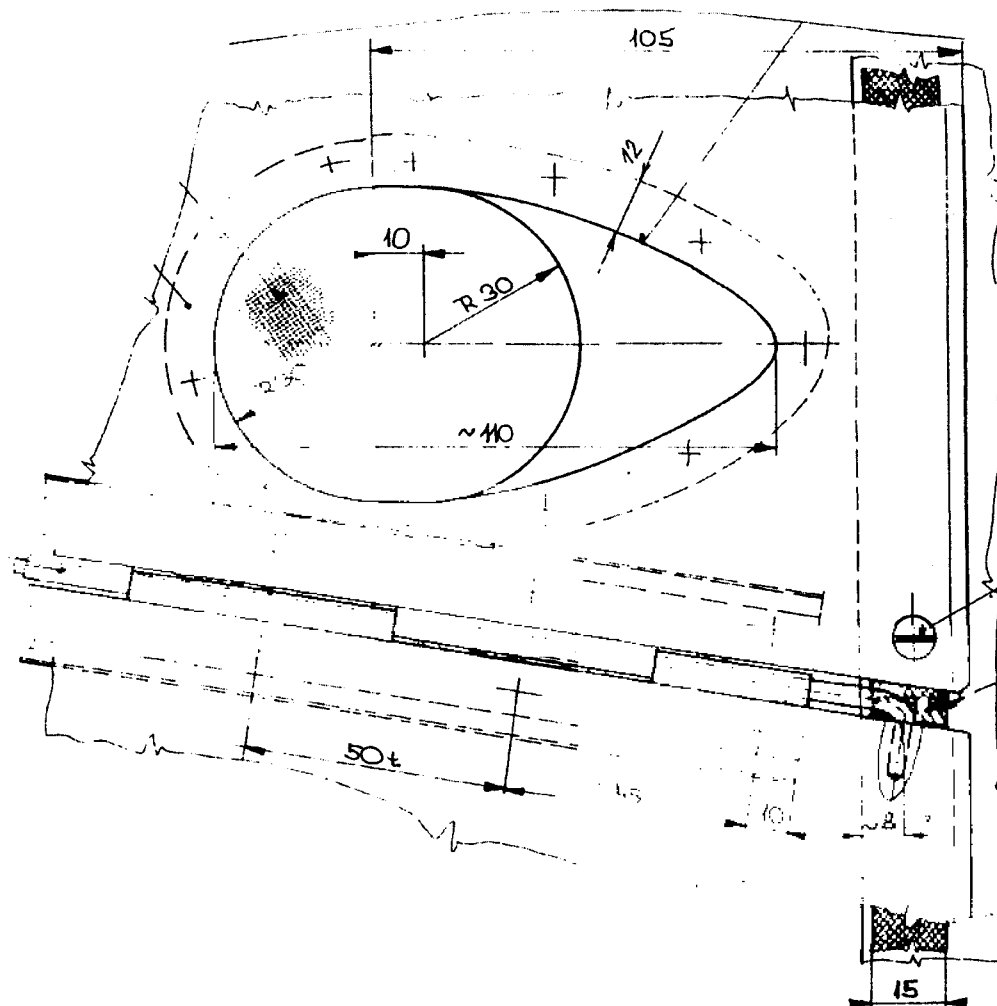
| <b>2. REASON:</b> | Intrusion of impurities into the carburetor leading to a possible engine failure can occur for the reason of the non-protected engine inlet. |

1. Drill out the inlet hole baffle on the upper engine cover.
2. Adjust the strainer shape according to the inlet hole with the allowance of 12 mm.
3. Set the baffle with strainer to the original position.
4. Drill and joggle holes for rivets.
5. Rivet. Pack out snap heads of rivets with packing.
6. Write down the bulletin accomplishment into the operation documentation.

1. Brass strainer, max. mesh size 1x1mm, dimension 140x90..... order No. 089200.... 1 pc
2. Packing.....order No. 736224.... 1 pc
3. Rivet 2.6 x 8 ČSN 02 2311.5..... order No. 045350....10 pc
